Environmental and Social Management Plan Monitoring Report 2022

**PT PLN (Persero)
East Java Distribution Main Unit**

AIIB – PLN Strengthening Distribution Networks in East Java and Bali Project

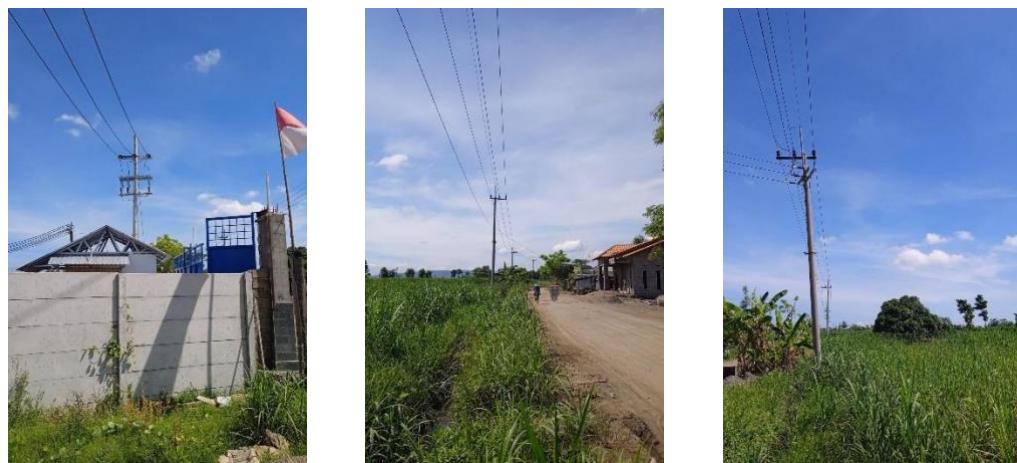
Figure 2. RoW dan Safe Distance on Distribution Power Lines

Constructing medium or low voltage network of JTM and JTR might affect in ecological, physical, and social aspects at pre-construction stage. In PLN UID Jatim, many of JTM and JTR construction have been conducted for mostly residents and industries. Before start any projects, the UP3, a sub unit of PLN, analyse the potential effects to environment, land, residents, indigenous people, and cultural heritage through screening form, seen in Appendix 5. The trees cutting and trimming under Right of Way (ROW) must be performed to ensure the networks reliability with the permission of landowners in agreement documents. A clear ROW route and written agreement shown in Appendix 15 and Appendix 11, respectively. The Figure 2 below shows the safety distance and RoW in this project.

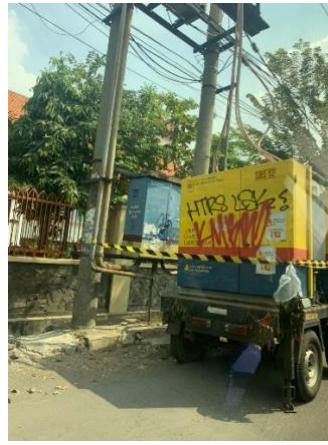
Figure 3. Police Line as a Work Sign

During construction activities, the third parties responsible on doing the construction, must meet all the requirements of PLN standard and government regulation such as CSMS certified contractor, HIRARC, working permit, and standard operational procedures implementation, filled in contract document between PLN UID Jatim and vendors. For instance, installation and demolition of JTM, substation cubicle, JTR, SR APP 3 phase at UP3 Bojonegoro. According to contract document No: 0123.PJ/HKM.02.01/C04020000/2022, the vendor has complied the requirements and assured the projects have been worked properly, as accommodated in Appendix 12 and 13. Figure 3 below shows the usage of police line as a work sign.

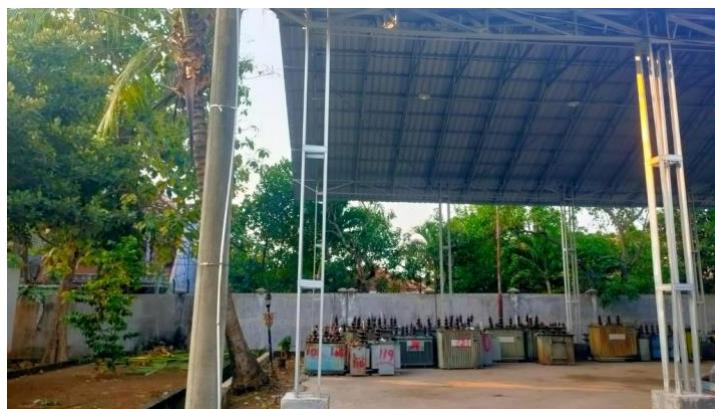
Figure 4. UID Jatim Transformer Warehouse Condition

Workers and society are the most affected parties during the operational stage. On the other side, waste is an affecting resource appears in this phase. An old transformers replacement, for instance, during transportation of an old transformer to a warehouse and it should be assured no oil spills from the transformer, and the warehouse must be covered as protection from rain. According to Government Regulation No. 22 of 2021, warehouse must be covered to protect from the rain and provided an oil trap to prevent environmental pollution regarding to oil spills or leakage. Figure 4 below shows an example of the warehouse condition in UID Jatim.

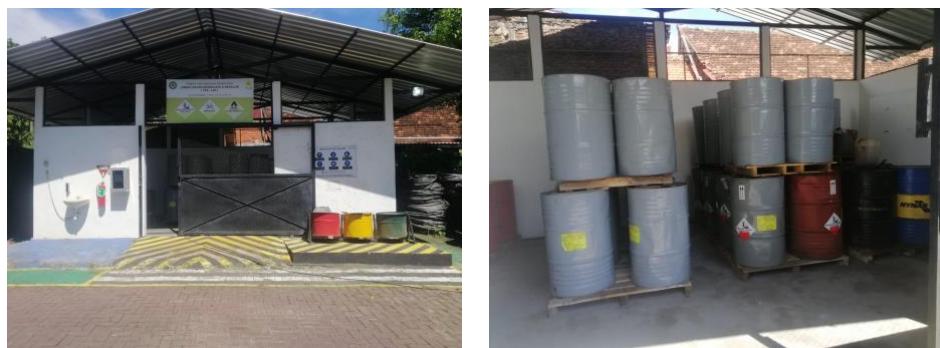
Figure 5. Hazardous Waste Temporary Storage at UP3 Madiun

The hazardous waste temporary disposal site is used for hazardous waste generated from power distribution activities such as used lubricating oil, battery, used battery, and used rags. Hazardous waste management is carried out with a third party owned a hazardous waste management permit from the Minister of Environment and Forestry. Before the hazardous waste given to the third party to be managed, it is stored at hazardous waste temporary storages in several areas in East Java Province, with the operating permit for each hazardous waste temporary disposal site (Tempat Penampungan Sementara – TPS) seen in Appendix 9. In 2022, PLN UID Jatim has developed environmental procedures for handling spilled oil, storage and treatment hazardous and chemical materials that integrated with Integrated Management System (IMS) of PLN UID Jatim as seen in Appendix 17. The condition of the hazardous waste temporary storages in the PLN UID Jatim area can be seen in Appendix 9, and Figure 5 below shows the condition in UP3 Madiun.

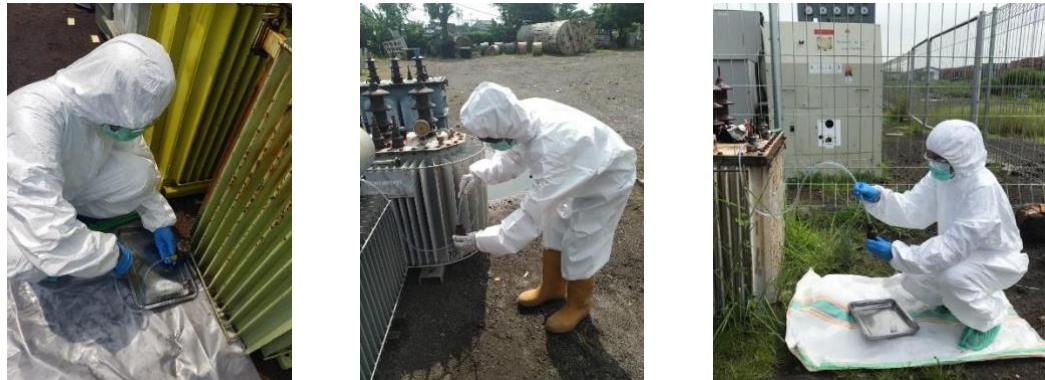
Figure 6. Transformer Offline Oil Sampling for PCBs Test

The PCBs testing was done in stages. In 2022, a PCBs test using the dексил method has been carried out for 91 offline transformer oil samples and 26 may contain PCBs because the test result shows the PCBs content is more than 50 ppm. Transformers that may contain PCBs would have a further test carried out by using the gas chromatography method, while transformers that do not contain PCBs are submitted to the third party as described previously. The results of PCBs testing using the dексил method can be seen in Appendix 10 and the PCBs test activity as in Figure 6.

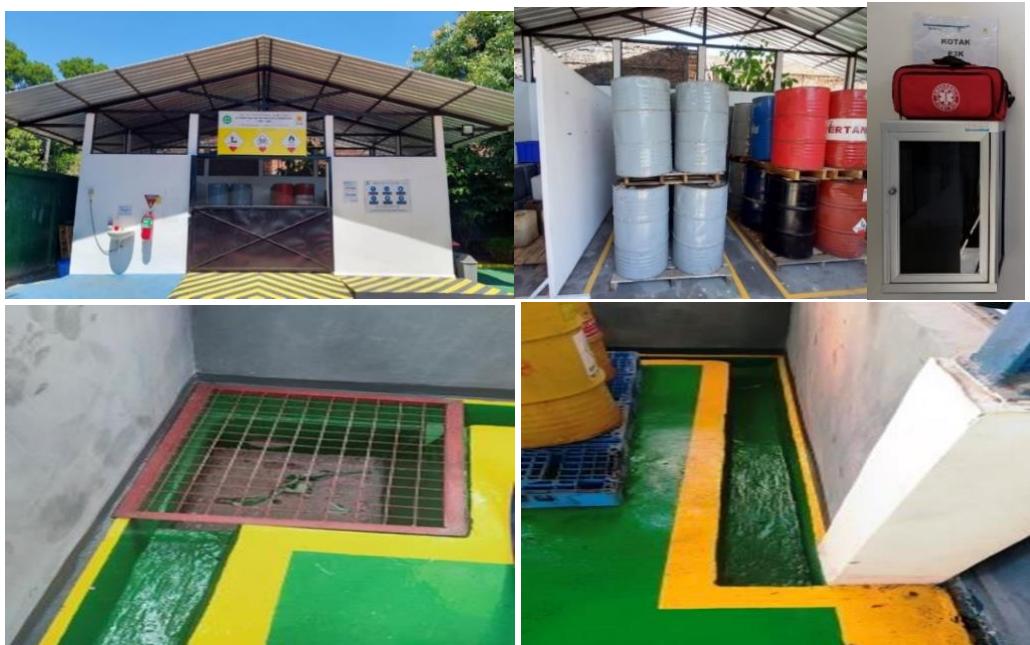
Figure 7. Hazardous Waste Temporary Storage

PLN UID Jatim has 18 hazardous waste temporary disposal sites. The company has endeavoured to provide proper storages based on Indonesian Government Regulation No. 22 of 2021. According to the data of PLN Headquarter, each disposal sites has been supplemented with roof covering, concrete floor, drainage systems connected to fat, oil trap, eyewash, first aid, fire extinguisher, the hazardous waste separation based on each category, housekeeping and transformation labelling. The condition of some facilities can be seen in Figure 7. Several storages might require minor refinement in the following year due to the age of warehouses and natural condition, like wind storming and sun exposure that causing rust stain roof.

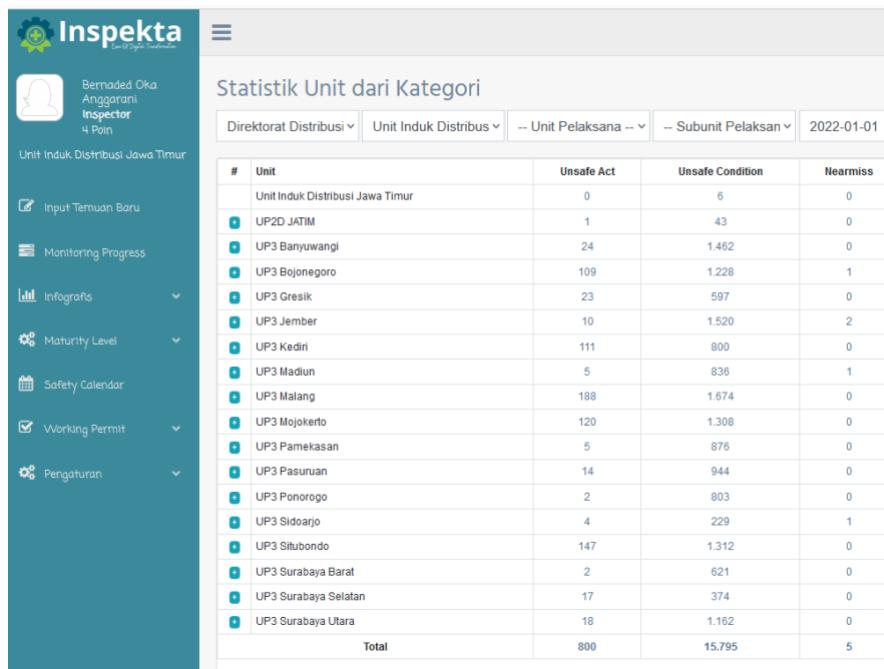
Figure 8. INSPEKTA Monitoring Report

Throughout 2022 the number of unsafe conditions were nearly to 95%, 15795 of 16600 cases at PLN UID Jatim, 4.8% unsafe actions and 0.02% near miss incidents as in Figure 8 below. Considering the large number of reporting on unsafe conditions, actions and measures taken by UID Jatim to improve safety management have been done by having and implementation of Standard Operational Procedure – SOP for each activity, like SOPs for Low and Medium Voltage Networks and Substations Maintenance; inspection by management; and field monitoring with report using social media and Inspekte website.

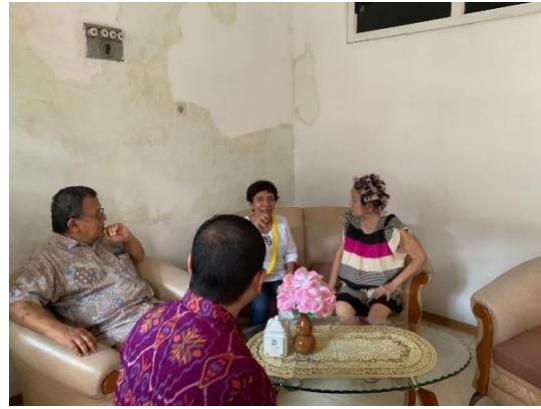
Figure 10. Interview – AIIB Team and House Owner

PLN UID Jatim with AIIB team had met a resident having her house nearby a pole that not met the safe distance regulation due to the land limitation. To note that the area and specifically the house has not and will not be in the coverage of AIIB Jatim Bali Distribution Project. Figure 10 below shows the discussion with the house owner.
